# CASE STUDY

## VARB—PF Diffuser at Ontario Power Station,

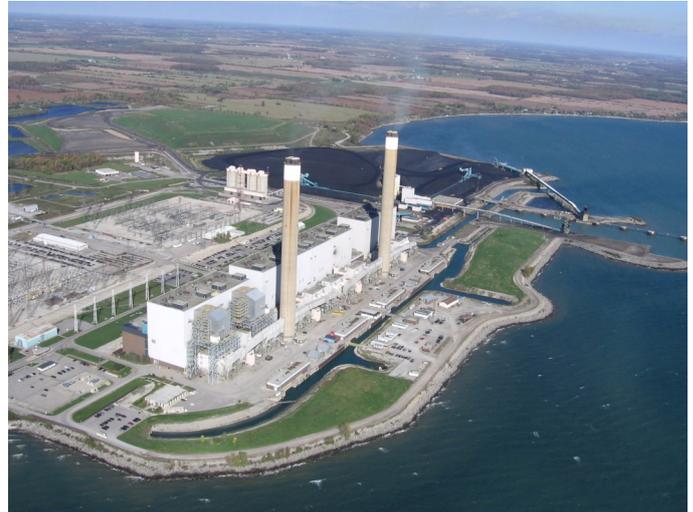
Figure 2: Installation layout showing all compo-

GAIM Ltd. provided CFD analysis to identify which VARB solution would be appropriate. It was decided that an aggressive VARB solution would be needed. The scenario had a tight horizontal to vertical bend and a limited envelope for any installation, as a result a H-VARB device would be utilized along with a control gate device.

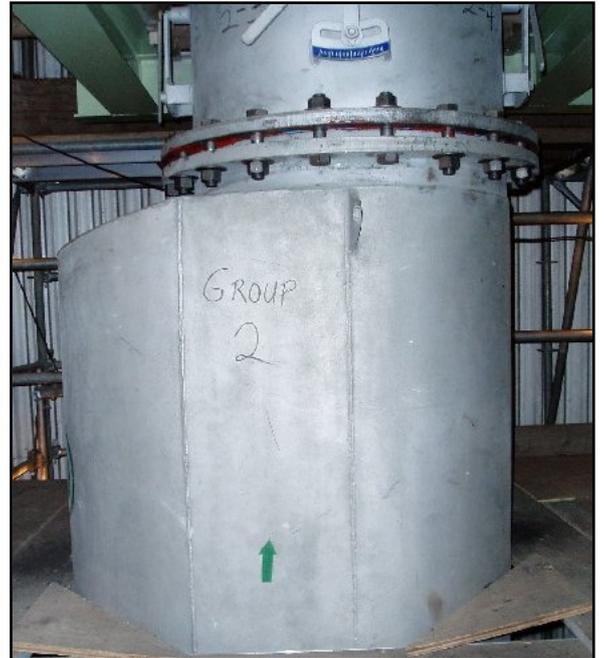
Figure 3: H-VARB in position at Nanti-

The investigation indicated the orientation of the H-VARB device and possible initial positions for the control gate plates to be positioned.

Following installation, observations from the PfMaster system allowed complete balancing of the system to within the given guarantee.
